UTAH STATE CAPITOL ARCHITECTURE: EXTERIOR SURVEY REPORT

ELEVATION LOCATION: NORTH ELEVATION

Survey Date: 4/25/00

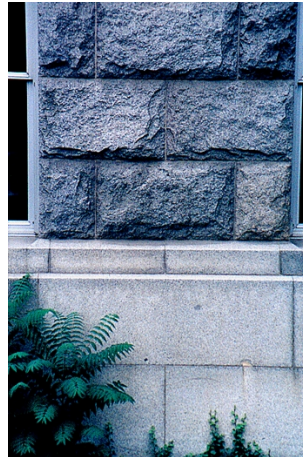
Description: Foundation stone

Location: East side

Condition: J, PAT

Mortar joint damage and poor quality patching

Comments: B/E 113

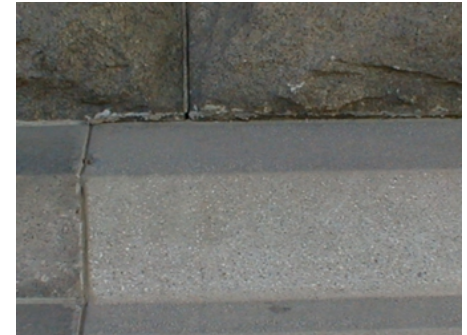
Description: Foundation stone

Location: center

Condition: J

Mortar joint with missing or loose mortar

Comments: where concrete meets stone

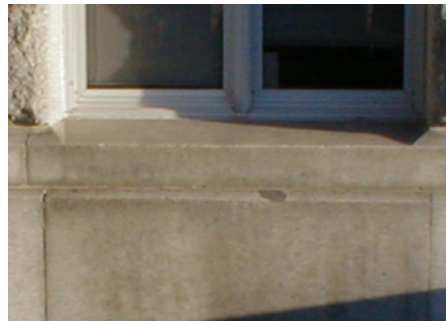
Description: Foundation stone

Location: West side

Condition: J

Mortar joint with missing or loose mortar

Comments: W 49-B, W 155-B, W 170-B

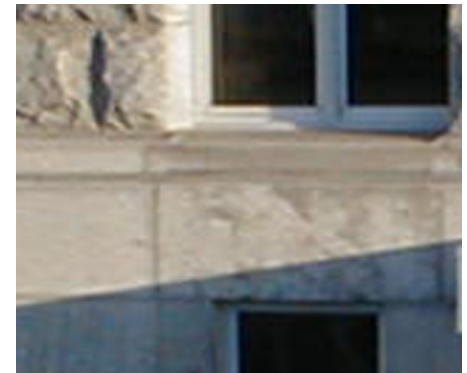
Description: Foundation stone

Condition: ST, C, B

Comments: ST--W 100-B

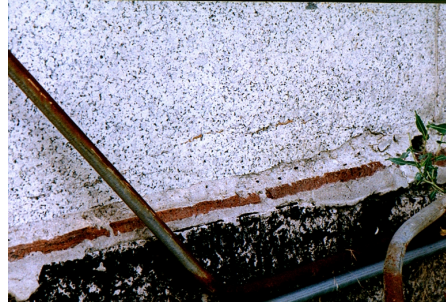
Description: Foundation stone

Location: West entrance

Condition: INT

Intrusive, non-original, non-essential element

Comments: metal pipe

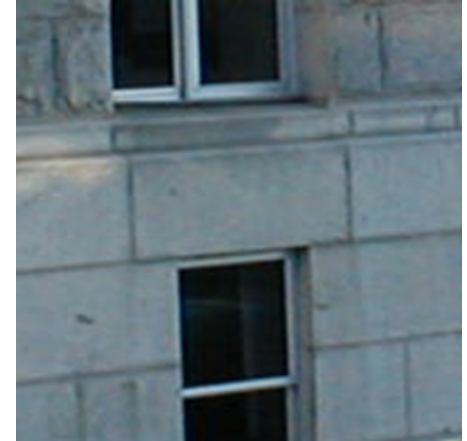
Description: Foundation stone

Location: North Elevation West side

Comments: J

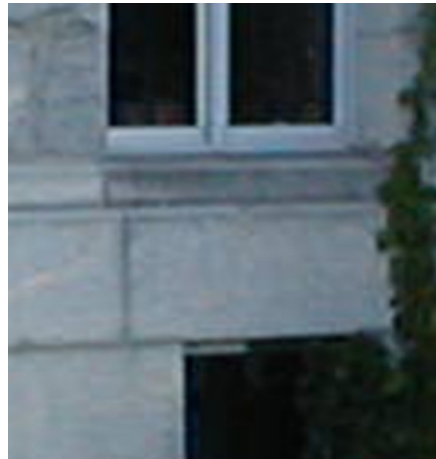
Description: Foundation stone

Location: North elevation West side

Comments: J

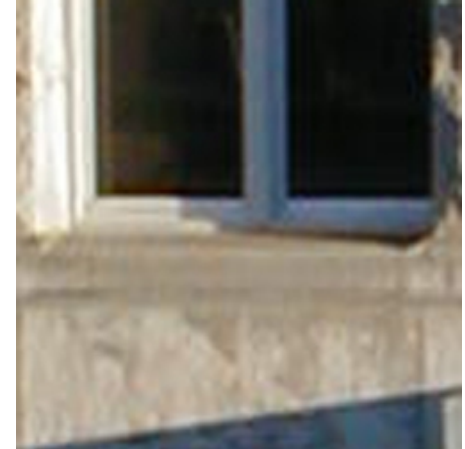
Description: Foundation stone

Location: North Elevation west side

Condition: BR

Broken, severely cracked or
chipped

Comments: B

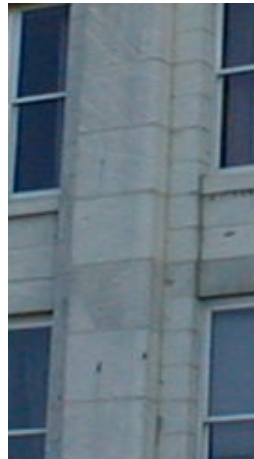
Description: Pilaster shaft

Location: North Elevation East entrance

Comments: PAT

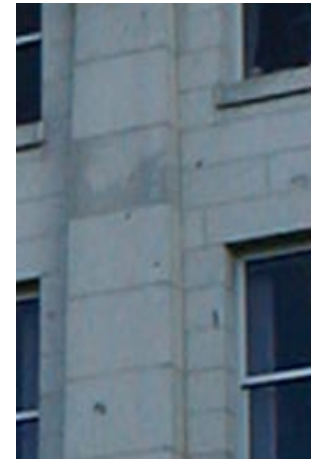
Description: Pilaster shaft

Location: North Elevation east side

Comments: PAT

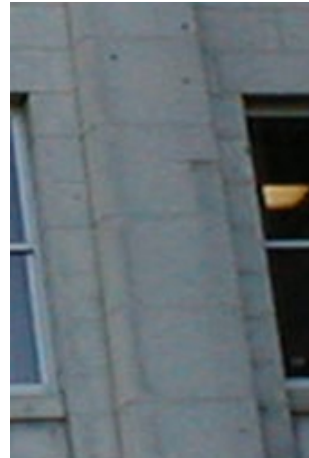
Description: Pilaster shaft

Location: North Elevation East side

Comments: PAT

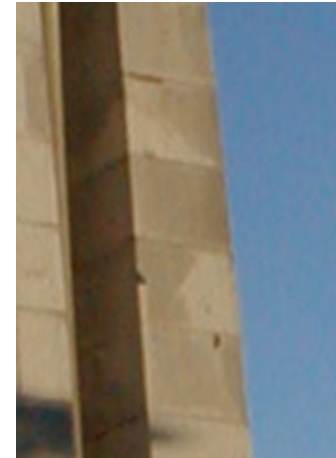
Description: Pilaster shaft

Location: North elevation West side

Condition: PAT

Poor quality, non-matching patch

Comments: Pat

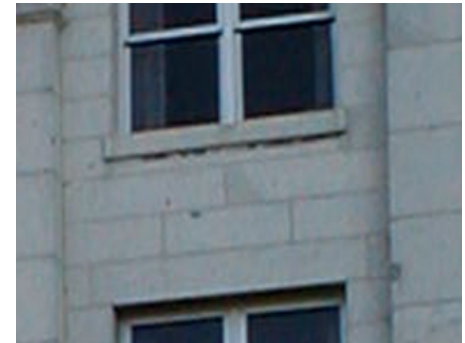
Description: Wall stone

Location: North elevation East side

Comments: PAT

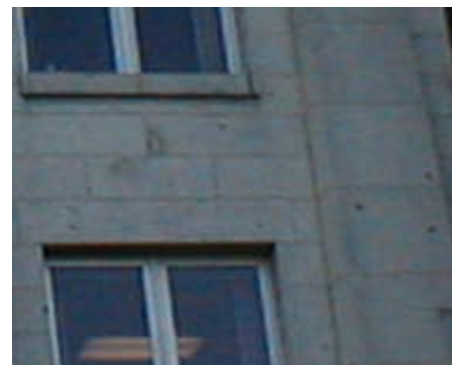
Description: Wall stone

Location: North Elevation East side

Comments: PAT

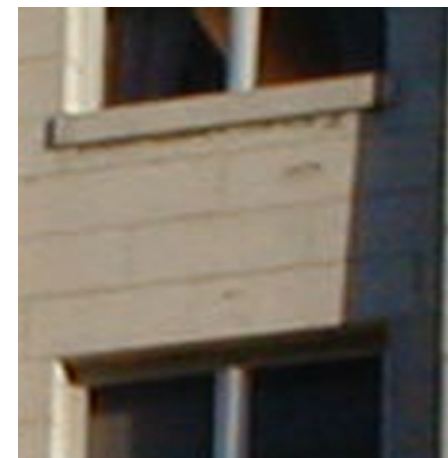
Description: Wall stone

Location: North Elevation West side

Condition: PAT

Poor quality, non-matching patch

Comments: PAT

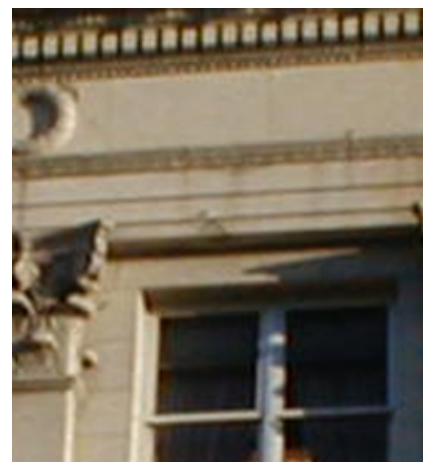
Description: Entablature lower belt

Condition: PAT

Poor quality, non-matching patch

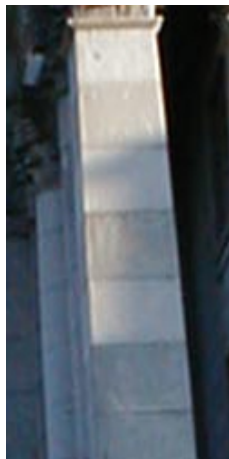
Description: Trim

Location: East entrance

Condition: PAT

Poor quality, non-matching patch

Comments: D&E/ E190

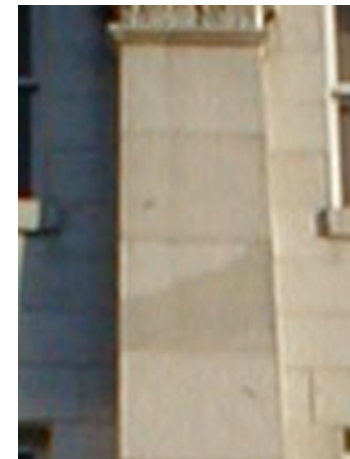
Description: Trim

Location: North Elevation West side

Condition: PAT

Poor quality, non-matching patch

Comments: PAT
